# Army Lodging Wellness Recommendation

## Fort Benning - Final Submittal

August 15, 2003

# Section 1 Wellness Recommendation

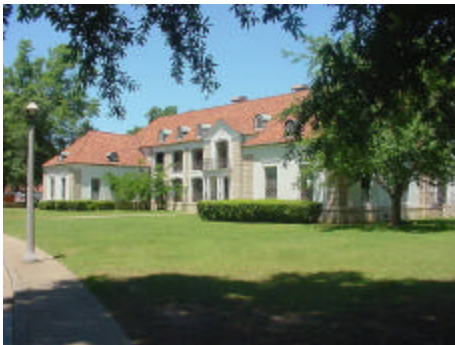
### ***Lodging Buildings 36, 37 & 38, “Lewis, Green, and Collins Halls”***

Buildings 36, 37, and 38, constructed in 1934, are all of similar construction and age. The three buildings are two stories tall, with partial basements with mechanical rooms and crawl space. They each house 18 family suites on the two main levels. Each family suite has a living room and separate bedroom. Access to the rooms is through an interior corridor. These buildings are in good condition but do not meet current Army Lodging requirements. The cost to make improvements and bring these buildings up to the new standards will exceed the 50% replacement cost.

Our recommendation is to remove buildings 36, 37, and 38 from the Lodging inventory, allowing the installation to determine an alternate use for these facilities. These facilities will be removed from the Fort Benning Wellness Solution and Lodging Master Plan.

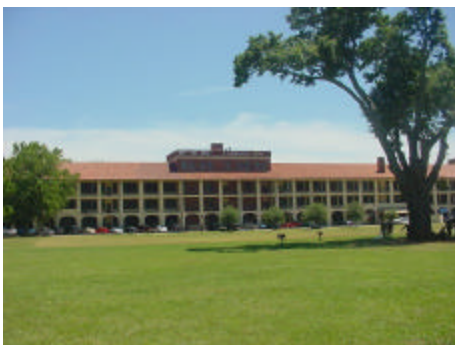
### ***Lodging Building 75, “McVeigh Hall”***

Building 75, constructed in 1924, is an historical structure with a full basement, housing 220 standard rooms. This facility shares space with tenants other than Army Lodging. Completely renovated recently, the building is typical of the construction of many buildings on the installation, and rooms are accessed from interior corridors without elevators. The building is in poor condition and does not meet current Army Lodging standards. The cost to make condition assessment improvements will exceed the 50% replacement cost.

Our recommendation is to remove building 75 from the Lodging inventory, allowing the installation to determine an alternate use for this facility. This facility will be removed from the Fort Benning Wellness Solution and Lodging Master Plan.

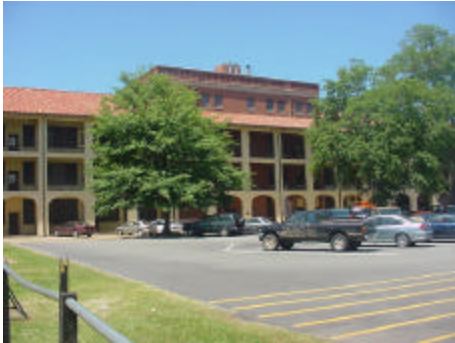
### ***Lodging Building 83, “Towle Hall”***

Building 83, constructed in 1935, is an historical structure with full basement, housing 213 standard rooms. This facility shares space with tenants other than Army. Completely renovated recently, the building is typical of the construction of many buildings on the installation, and rooms are accessed from interior corridors without elevators. The building is in poor condition and does not meet current Army Lodging standards. The cost to make condition assessment improvements will exceed the 50% replacement cost.

Our recommendation is to remove building 83 from the Lodging inventory, allowing the installation to determine an alternate use for this facility. This facility will be removed from the Fort Benning Wellness Solution and Lodging Master Plan.

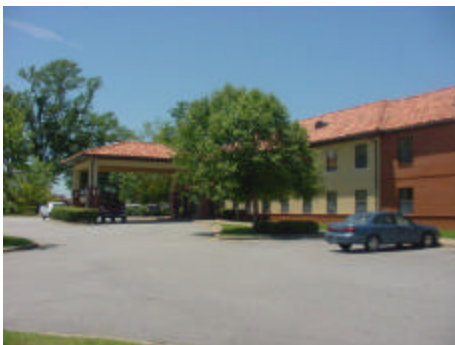
### ***Lodging Building 96, “Gavin Hall”***

Building 96, constructed in 1994, is a two-story structure housing 28 extended stay rooms, 266 square feet each, and 32 one-bedroom guest rooms with kitchens, 370 square feet each. The building has a 340 square foot gift shop and a 600 square foot administration area directly adjacent to the front entrance. Facilities previously used for check-in have been removed and turned into lobby/breakfast space. The building has some main facility back-of-the-house and public spaces including in-house laundry, a maintenance room, front desk, and a few offices. These spaces will not be required with the recommendation of a new main Lodging facility as part of the Wellness Solution. The guest rooms are accessed from interior corridors, and a single elevator services both guests and housekeeping.

The 32 one-bedroom guest rooms do not meet Army Lodging size standards for family suites. It is our recommendation to renovate the room to a large extended stay room, at 370 s.f., in lieu of a too small family suite.

The building is in good condition and relatively new in age. Although renovation to guest rooms and some of the public and back-of-house areas is required, the cost to make improvements and bring this building up to the new standards will not exceed the 50% replacement cost.

Our recommendation is that building 96 remain in the Lodging inventory and continue to serve as part of the Fort Benning Wellness Solution and Lodging Master Plan.

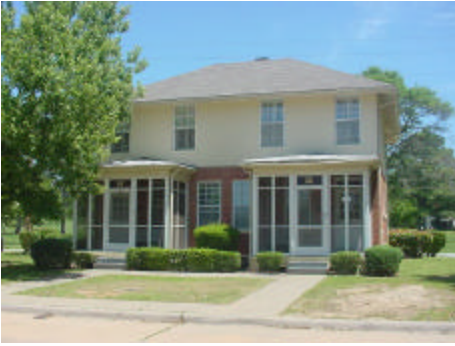
***Lodging Buildings 365, 367, 369, 371 & 373 “McIver DVQ Complex”***

Buildings 365 (Lynch & Freeman Suites), 367 (Gordon & Fansworth Suites), 369 (Church & O’Daniel Suites), 371 (Walker & Bonesteel Suites), and 373 (King & Allen Suites), constructed in 1923, are of similar construction and age. All are DVQ suites; they are two-story, duplex suites, with either one or two bedrooms on the upper floor, and living room and full kitchen on the lower floor. These buildings are in good condition but do not meet current Army Lodging standards. The cost to make improvements and to bring these facilities up to the new standards will exceed the 50% replacement cost.

Our recommendation is to remove these buildings from the Lodging inventory, allowing the installation to determine an alternate use for these facilities. These facilities will be removed from the Fort Benning Wellness Solution and Lodging Master Plan.

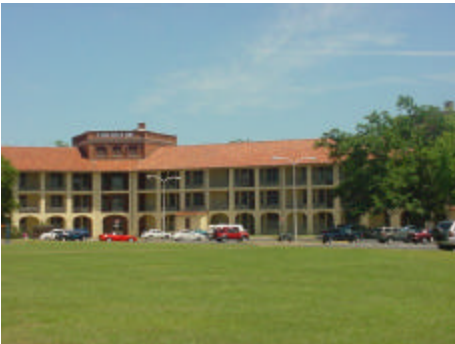
***Lodging Building 399, “Olson Hall”***

Building 399, constructed in 1929, is a three-story historical structure housing 597 guest rooms. It is of similar construction and layout to both buildings 75 and 83, and is nearly ½ mile in length. It serves as the primary Lodging check-in for the installation and houses the Lodging administration offices. The building meets current Army Lodging size standards but is in poor condition. The cost to make condition assessment improvements will exceed the 50% replacement cost.

Our recommendation is to remove building 399 from the Lodging inventory, allowing the installation to determine an alternate use for the facility. This facility will be removed from the Fort Benning Wellness Solution and Lodging Master Plan.

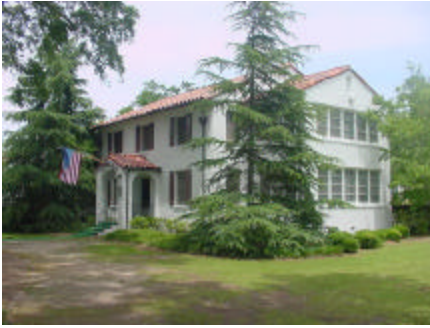
### ***Lodging Building 791, “Marshall House”***

Building 791, constructed in 1930, is a two-story historical residential structure, with a two-story 3-season porch, housing one DVQ unit with kitchen. There are three bedrooms on the second floor, and a living room, dining room, kitchen, and study on the first floor. There are 2 bedrooms and additional living space in the lower level. The Protocol function for the installation is also housed in the basement.

The building is in good condition but does not meet current Army Lodging standards. The cost to make improvements and to bring this facility up to the new standards will exceed the 50% replacement cost.

Our recommendation is to remove building 791 from the Lodging inventory, allowing the installation to determine an alternate use for this facility. This facility will be removed from the Fort Benning Wellness Solution and Lodging Master Plan.

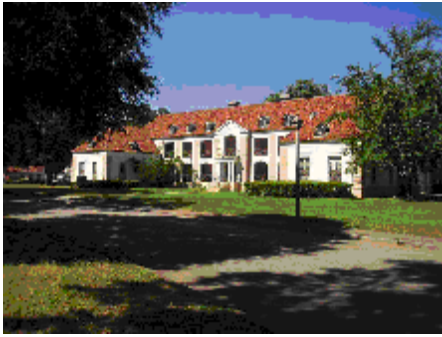
Bldg .036

Because the Renovation to Replacement Cost Ratio is greater than 50%, renovation of Building 36 is not recommended.

- Analysis: The aluminum windows are single glazed and in fair condition.
- Recommendation: Replace windows with insulated glass system.
